CASE STUDY CHILE

ARSENIC CONTAMINATION REMOVED BY TRUNZ WATER SYSTEMS

Chile / Putre

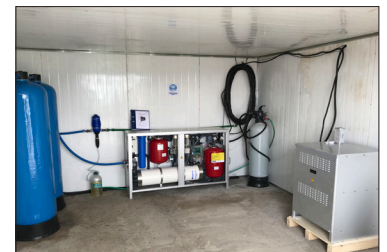
Technical layout

1 Water source
2 Solar direct pump system
3 Raw water tank
4 Solar Power Center TSPC (Solar Panel, Batteries, Inverter, Controller etc.)
5 Trunz Water Container (TWC) incl arsenic removal.
6 Water storage tank(s)
7 drinking water
